# Hydrology, Geomorphology, and Flood Profiles of the Mendenhall River, Juneau, Alaska

Water-Resources Investigations Report 99-4150

By Edward G. Neal and Randy H. Host

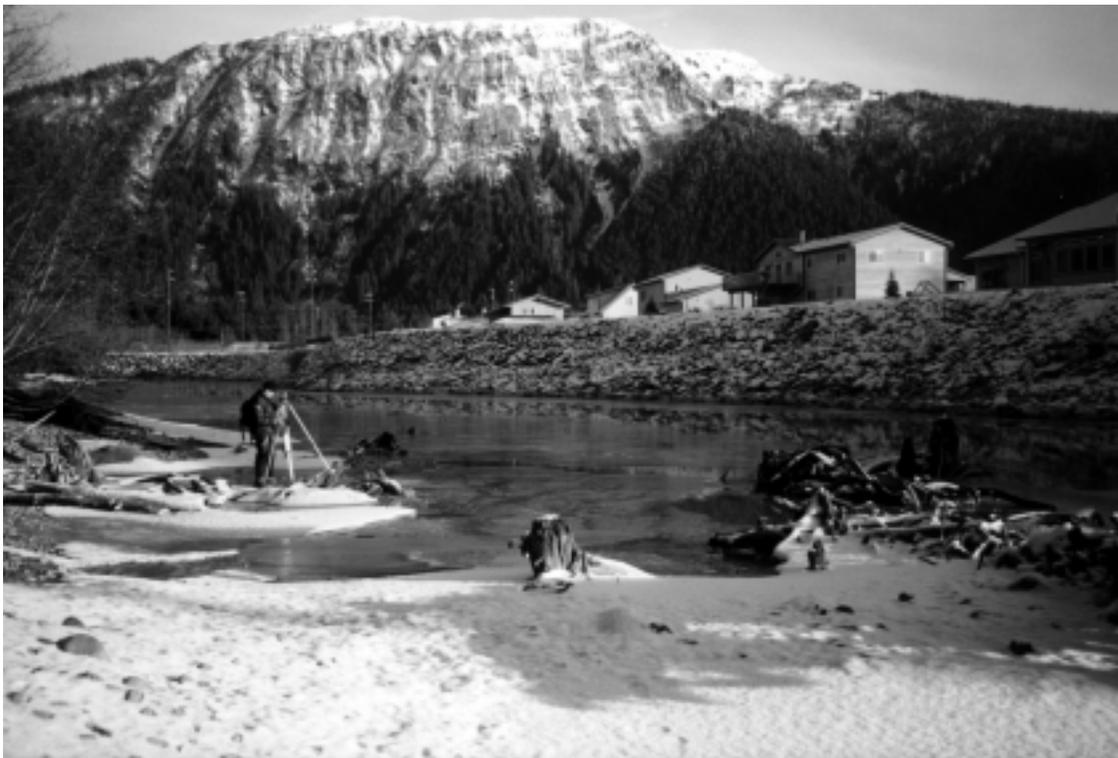
Cover: Surveying flood marks on the Mendenhall River near cross section 74

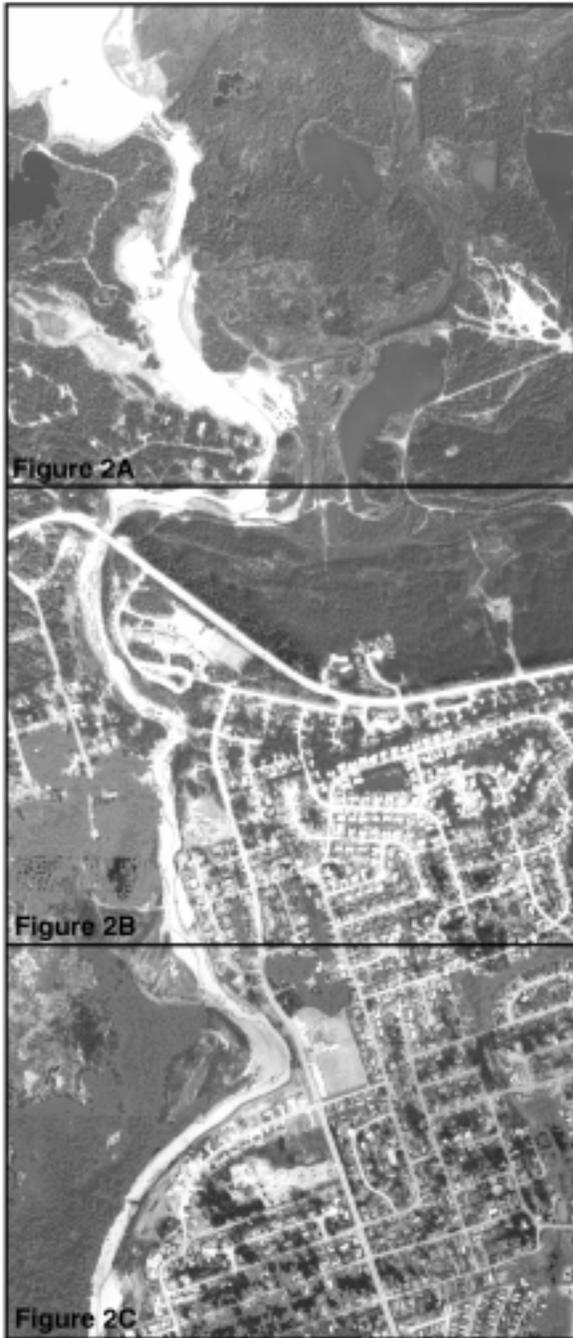
**Figure 2.** Aerial view of Mendenhall River from Mendenhall Lake outlet to mouth of Fritz Cove. Locations of selected cross sections and reference marks (RM) shown on figures 2A-2F. (Aerial photos of April 22, 1998 provided by R&M Engineering.)

Computed water-surface profiles of the river between Mendenhall Lake and Fritz Cove (fig. 2) have slopes ranging from less than 0.001 in the tidally influenced reaches to about 0.012 in the steepest reach. Just above the Mendenhall Loop Road Bridge (cross section 93, fig. 2B), the water-surface slope decreases to the approximate slope observed in the lower reaches of the river. The steepest reach of river extending upstream from cross section 86 to cross section 94 (fig. 2B) has cut through a large terminal moraine of the Mendenhall Glacier. Bed materials in this reach consist predominantly of large angular boulder material with diameters exceeding 8 ft. The size of the bed material controls the slope of the river throughout most of this reach. The finer grained moraine sediments have been winnowed away leaving the larger material in the channel. The stream lacks the competence to transport the larger bed material, consequently limiting further downcutting of the streambed and controlling the slope through this reach of the river. Large glacially transported boulders are also

The reach extending from cross section 64 (fig. 2D) to cross section 85 (fig. 2B) has bed material composed of relatively erosion-resistant peat deposits—formed by forest growth—which have been buried by subsequent alluvium. The remnant root structures and trunks of trees remain upright and intact in several parts of the channel (fig. 3). These deposits appear persistently throughout the reach, although they are covered by gravel and cobbles in some areas. Downstream from cross section 64, the channel bed has incised below the peat layer. Upstream from cross section 64, the channel bed has scoured through the peat layer intermittently indicating that this layer may eventually erode.

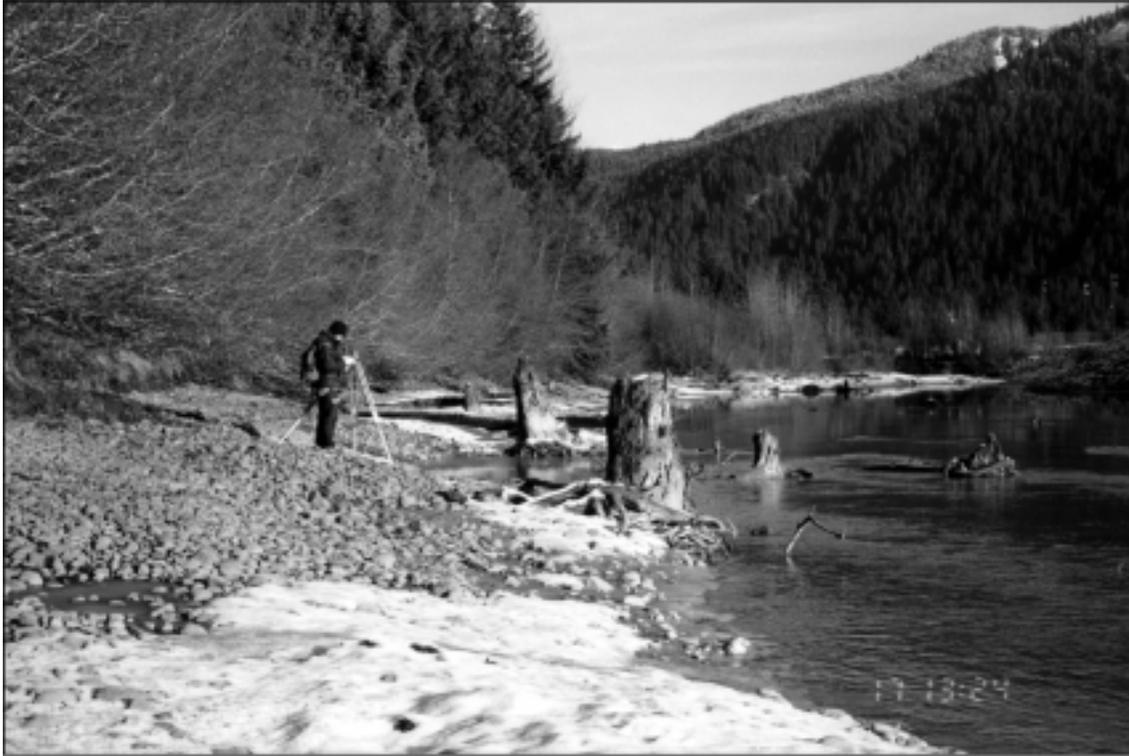
**Figure 3.** Upright stumps and root structures in channel bed, Mendenhall River, Alaska. (View is looking upstream from cross section 73).

Channel incision is slowed if there is an abundant sediment supply from upstream or if the river channel is heavily armored by materials that resist erosion. The large sediment supply from Mendenhall Glacier, however, is trapped by Mendenhall Lake and does not reach the river. The relatively small contribution of sediment from Montana Creek is not sufficient to prevent further incision of the Mendenhall River. The rate of incision, however, is slowed in the upper reaches by armoring of the banks and bed of the river. Above cross section 86, the river is armored by large boulders. Between cross sections 64 and 85, the river is armored by a mat of peat tied together by roots and trunks of dead trees. As this vege-
